Memorandum

Date: *August 15, 2014*

Subject: *Oversight Summary Report
CPG Oversight of RM 10.9 Removal Action
Lower Passaic River Restoration Project*

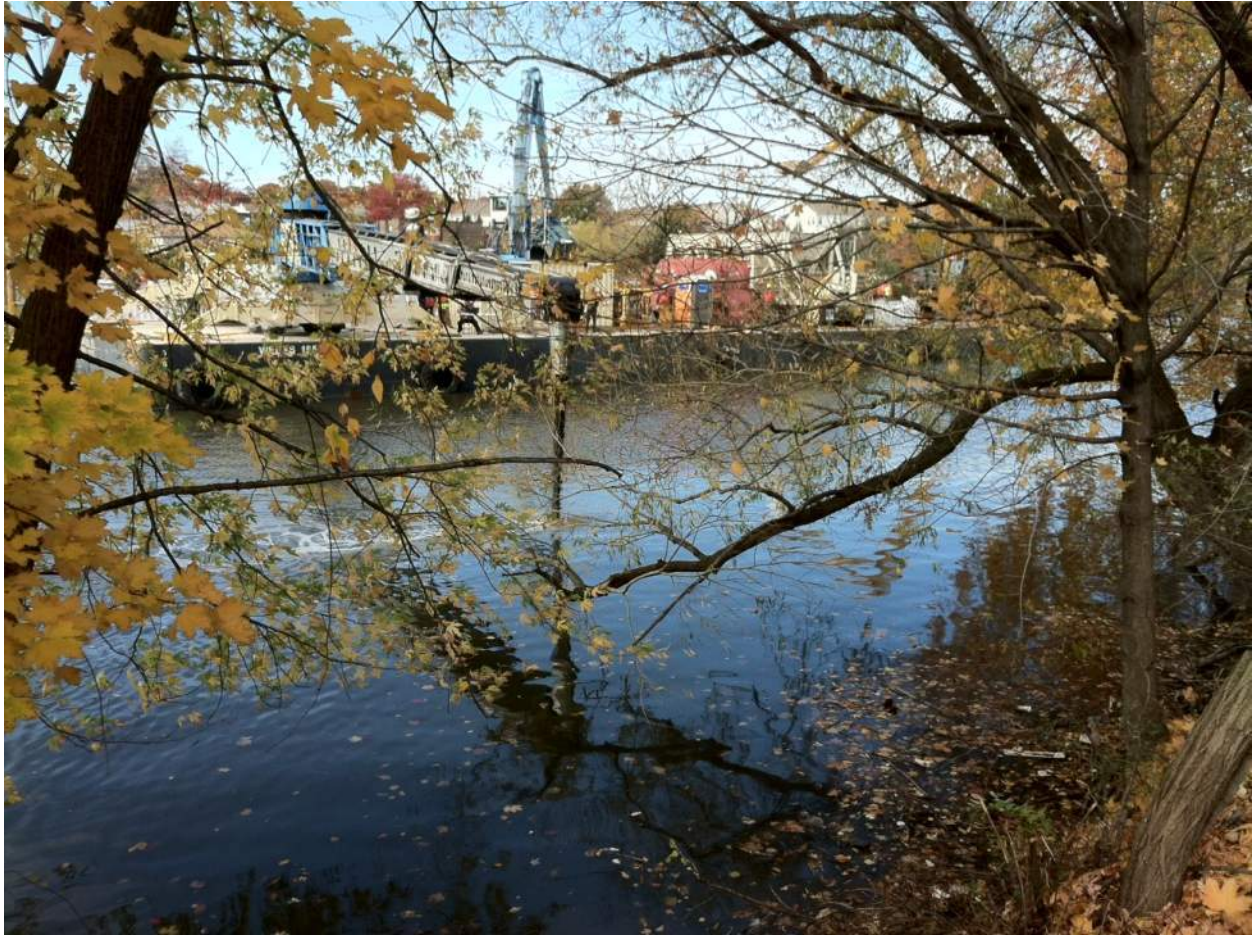
November 9, 2013 12:30 – first test placement of sand-Aquagate mix. No significant turbidity plumes observed.

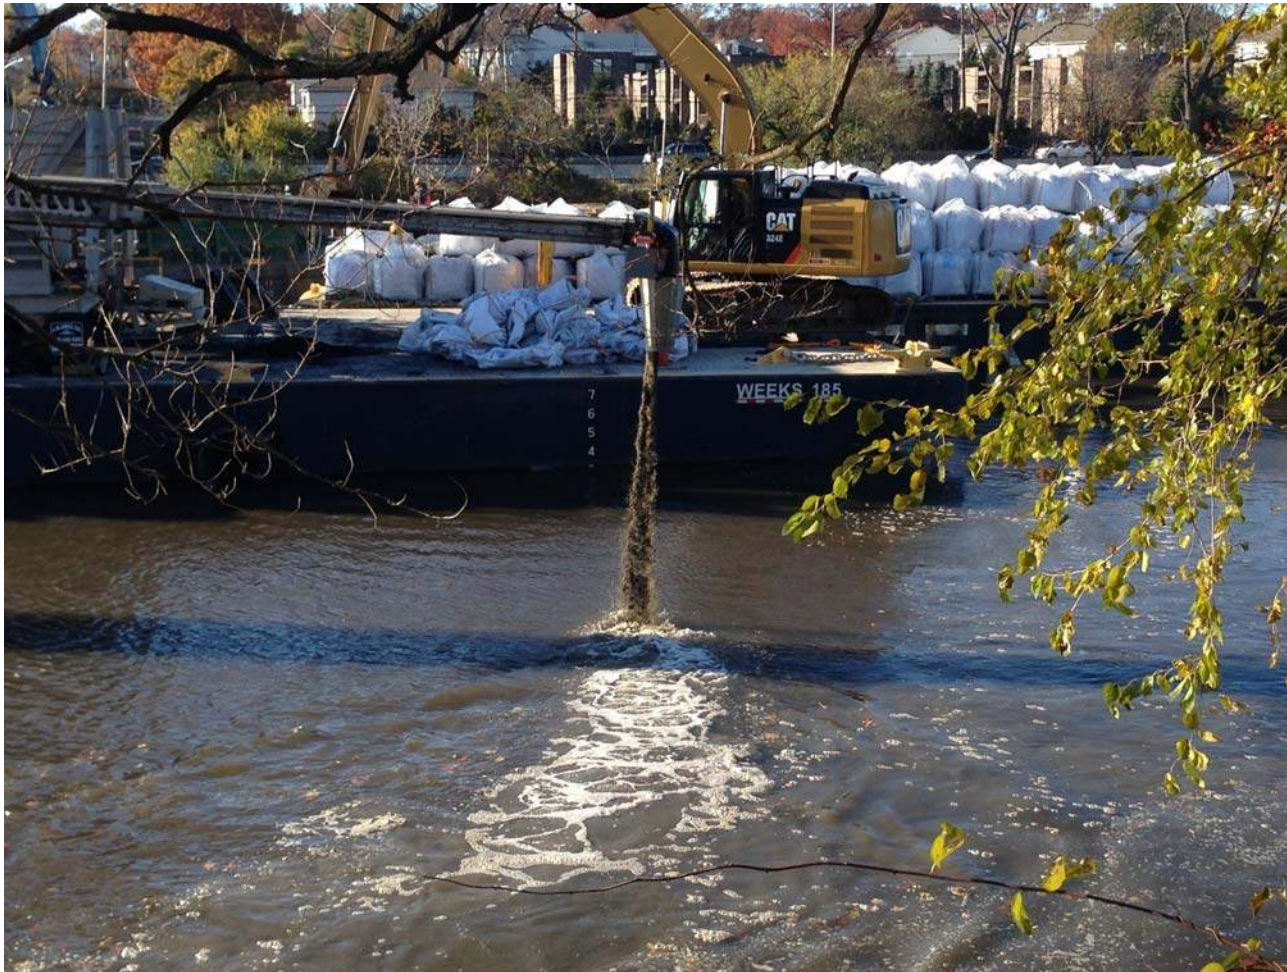
Turbidity Plumes

Some visible turbidity is generated during placement of the sand/Aquagate mixture, however it tends to dissipate within 10-15 feet of the placement location.

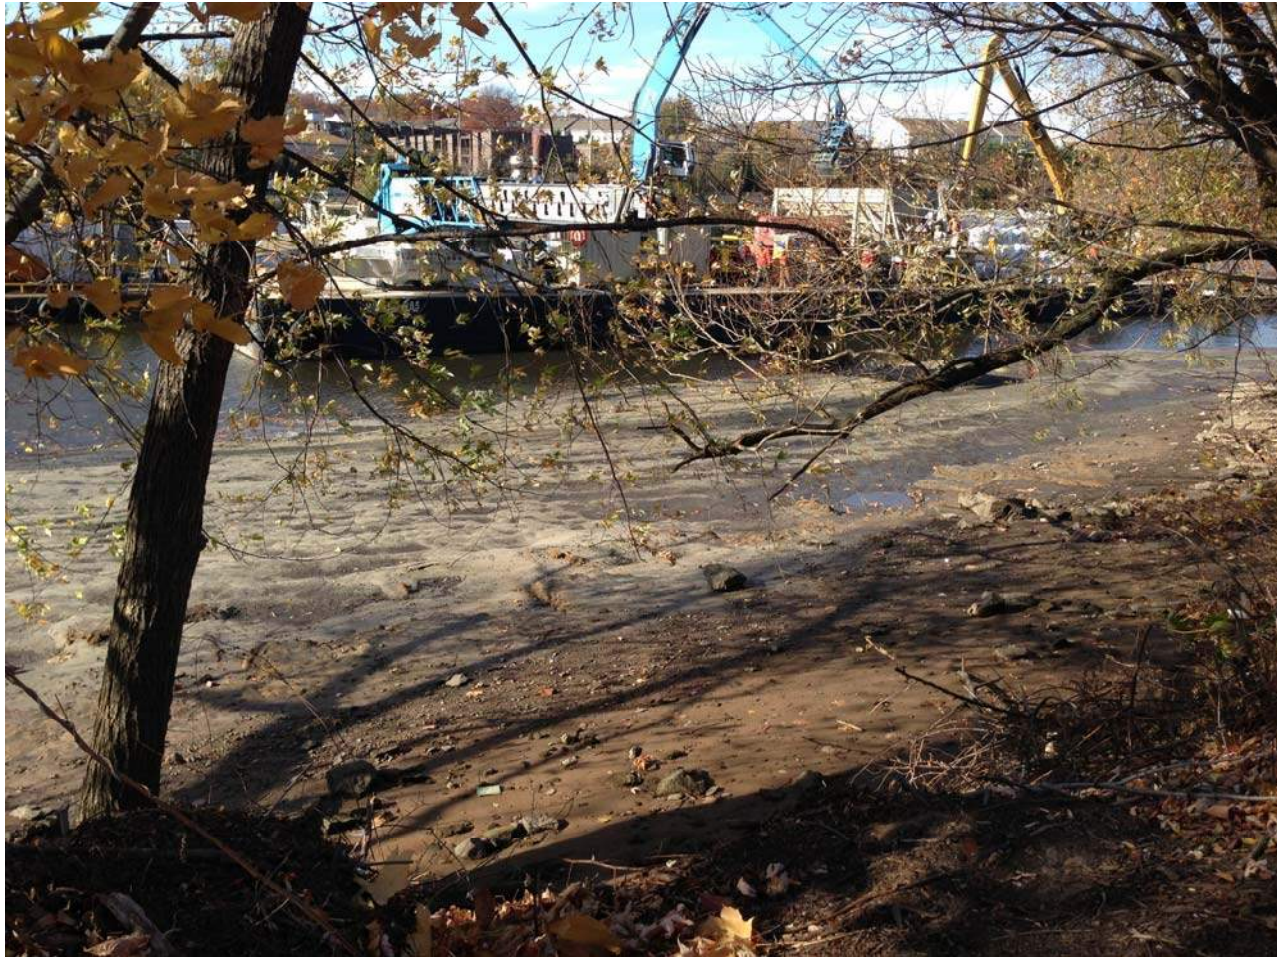
Sand/Aquagate Placed Yesterday

Capping was delayed today due to failure to get the generator running for an extended period of time. The above photo was taken around low tide and shows material that was placed yesterday. Push cores collected by GLDD contained sand/Aquagate at thicknesses of around 10 inches.

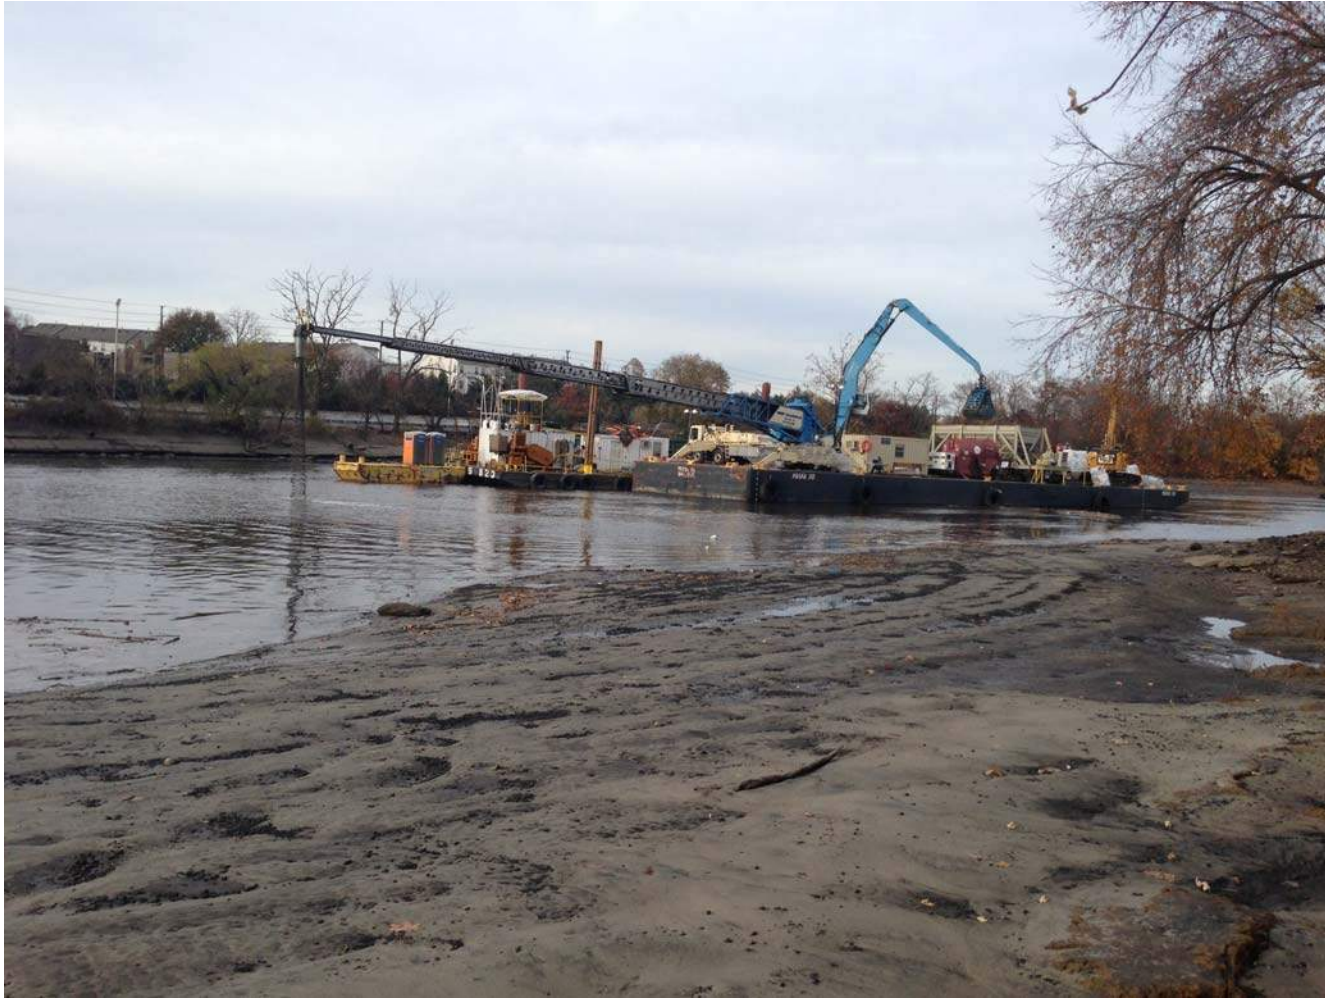
Capping Progress

Capping took place throughout the day. In the foreground of this photograph is the sand/Aquagate deposited earlier in the week.

The shallow water turns dark when Aquagate is first deposited, suggesting some amount of carbon suspension. Furthermore, when one of the GLDD workers planted an oar in the capped sediment a small black plume was observed from the carbon in the Aquagate.

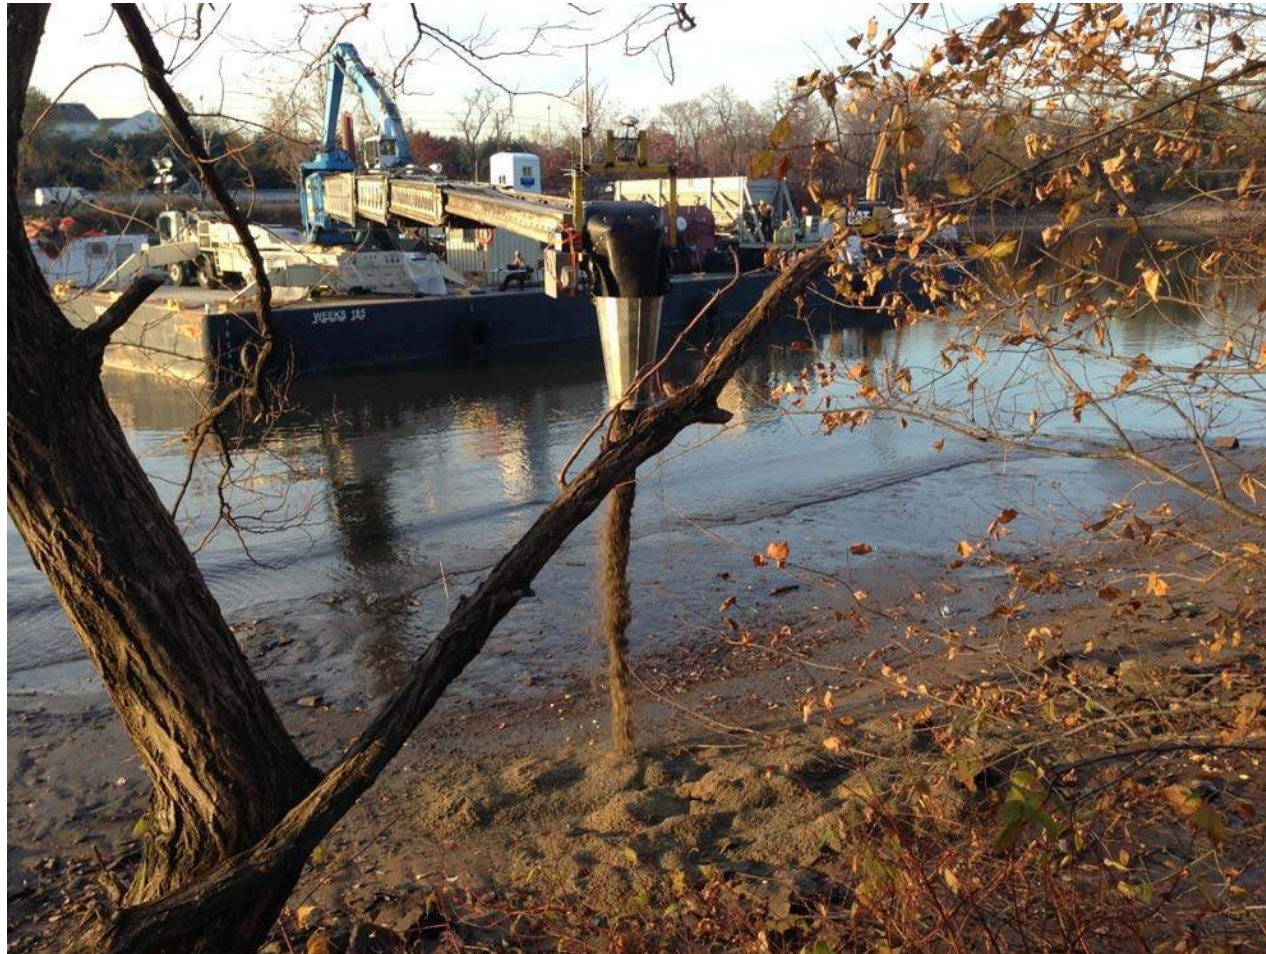
Sand/Aquagate Mixture

The mixture of sand and Aquagate appears fairly well-mixed in the air and on the ground, as shown in the above photograph. It is difficult to confirm whether this is true as it settles in water.

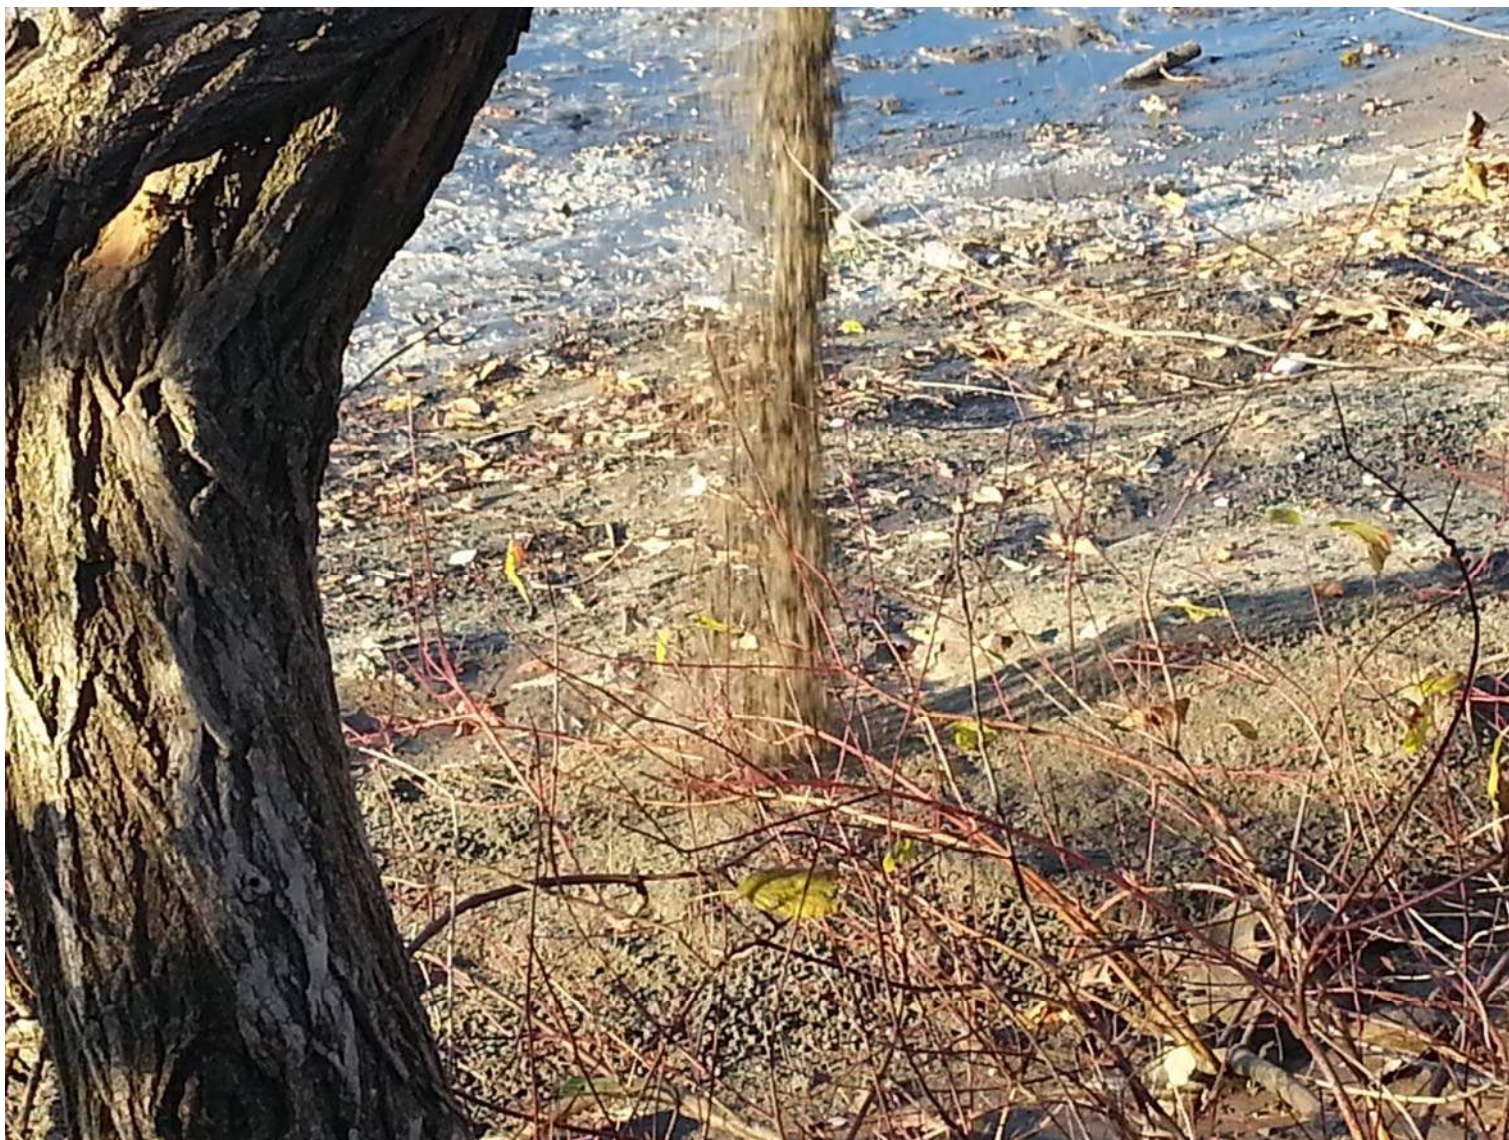
November 18, 2013 1445: GLDD placing Sand/Aquagate cap, lift thickness is approximately 3 inches.

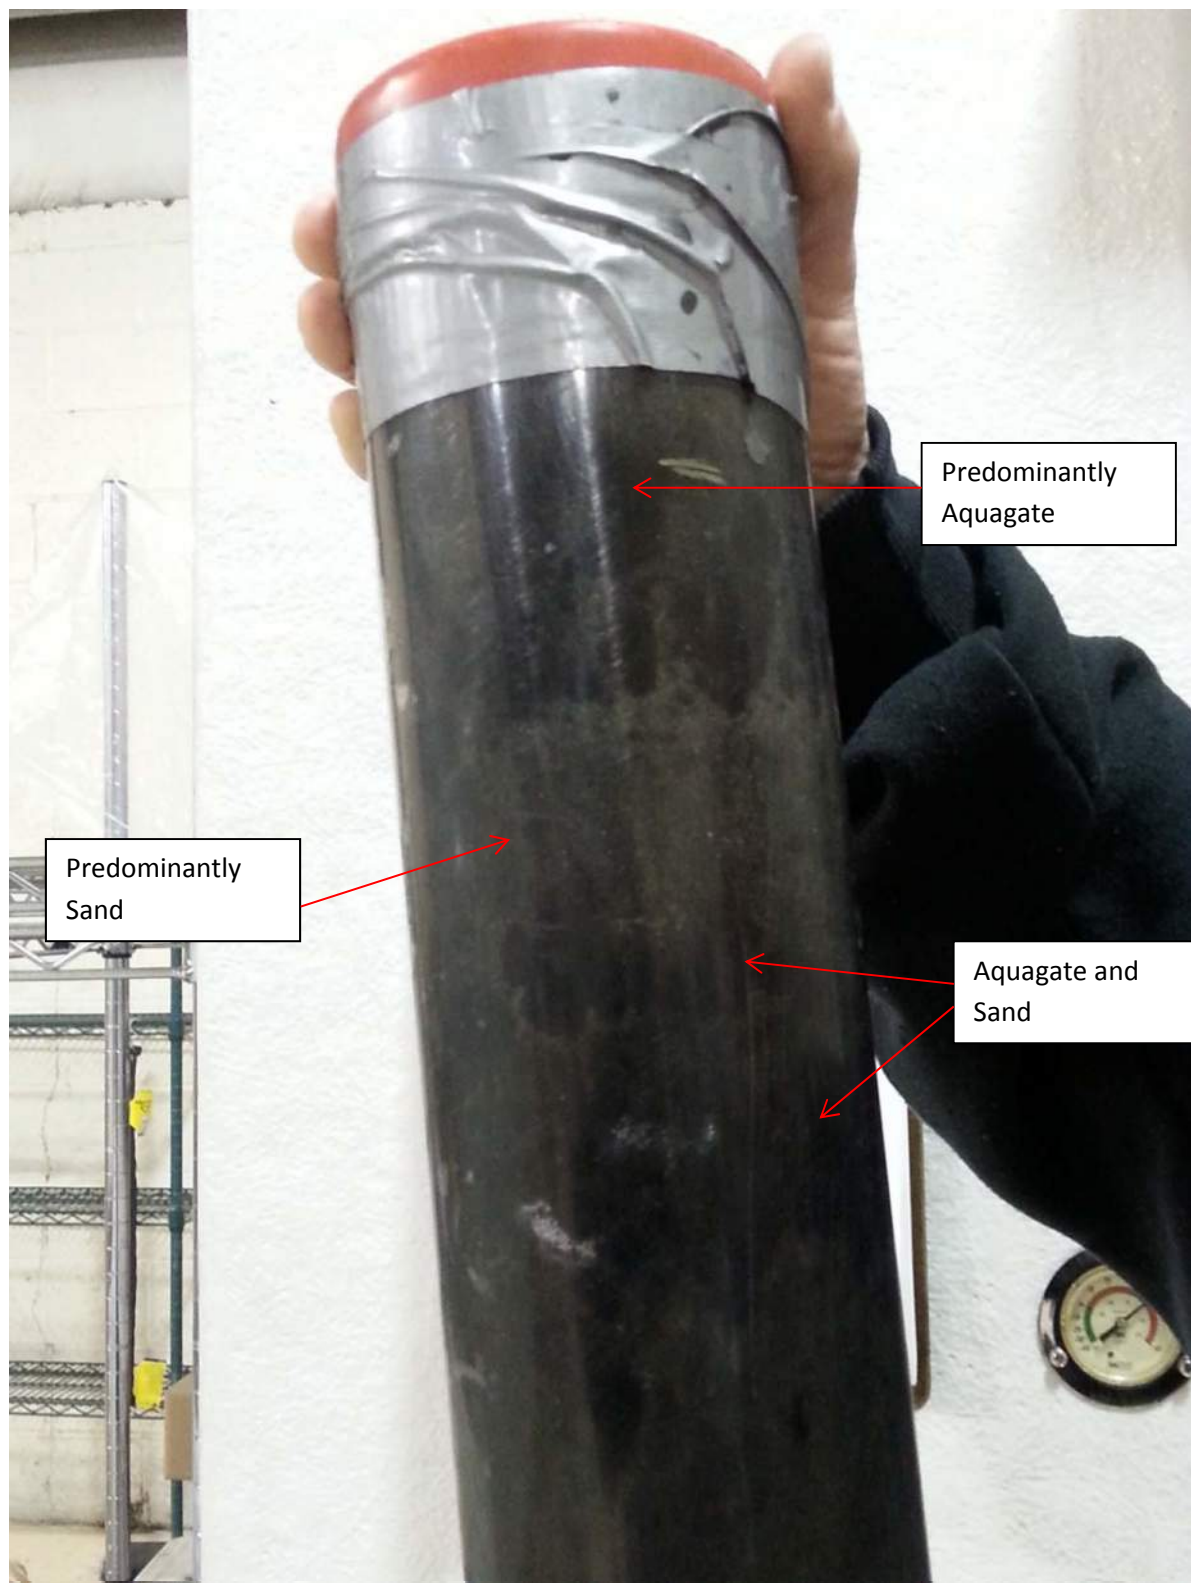
November 19, 2013 1400: Sediment core collected by CH2M Hill yesterday. The core was collected to determine the makeup of the cap, by visual analysis and TOC analysis.

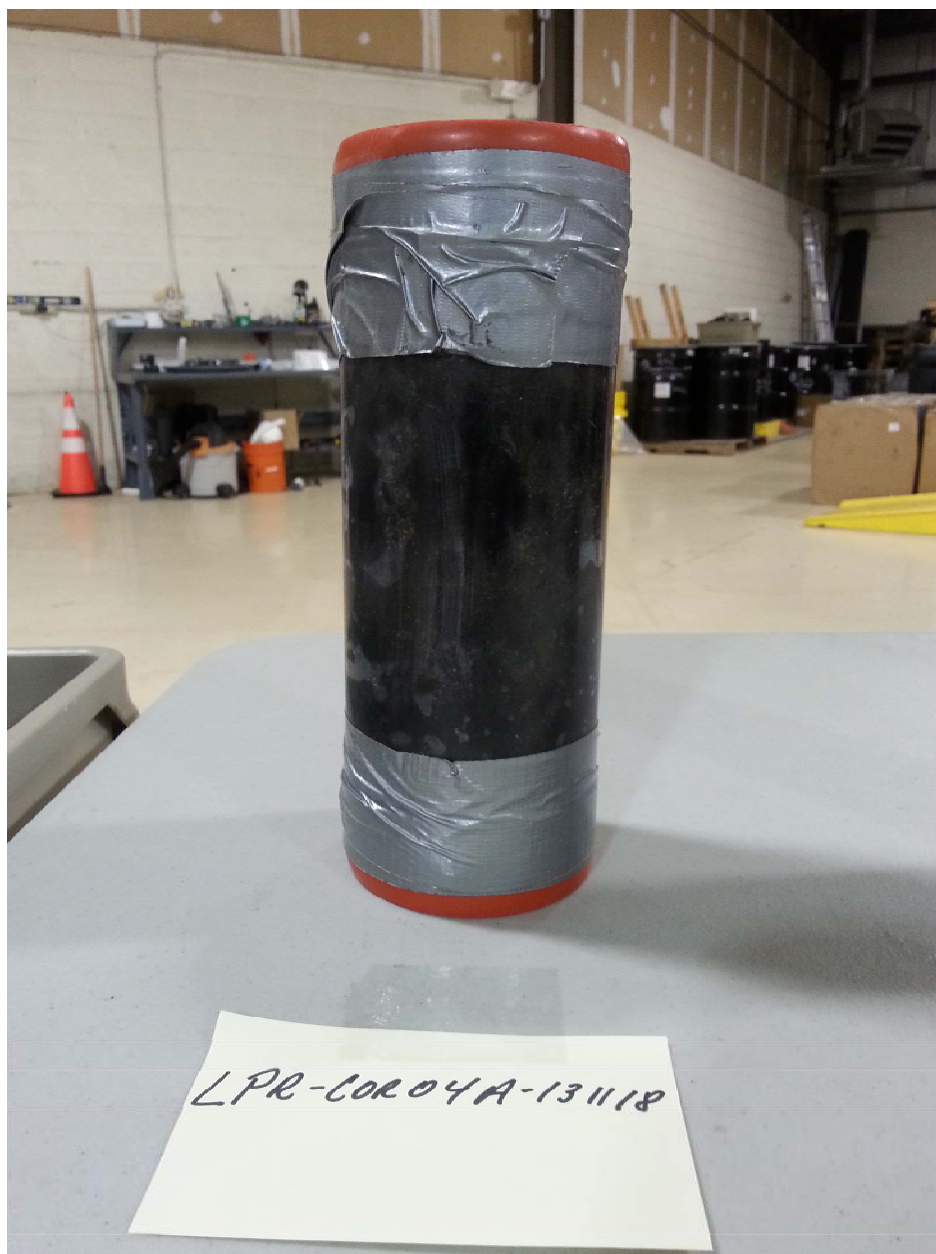
November 21, 2013 1430: Sediment core collected by CH2M Hill on November 18, 2013. The core was collected to determine the makeup of the cap, by visual analysis and TOC analysis. This is the 10-inch sample of cap, to be sent to lab for analysis. It is difficult to differentiate between the sand and AquaGate because the core is now frozen.

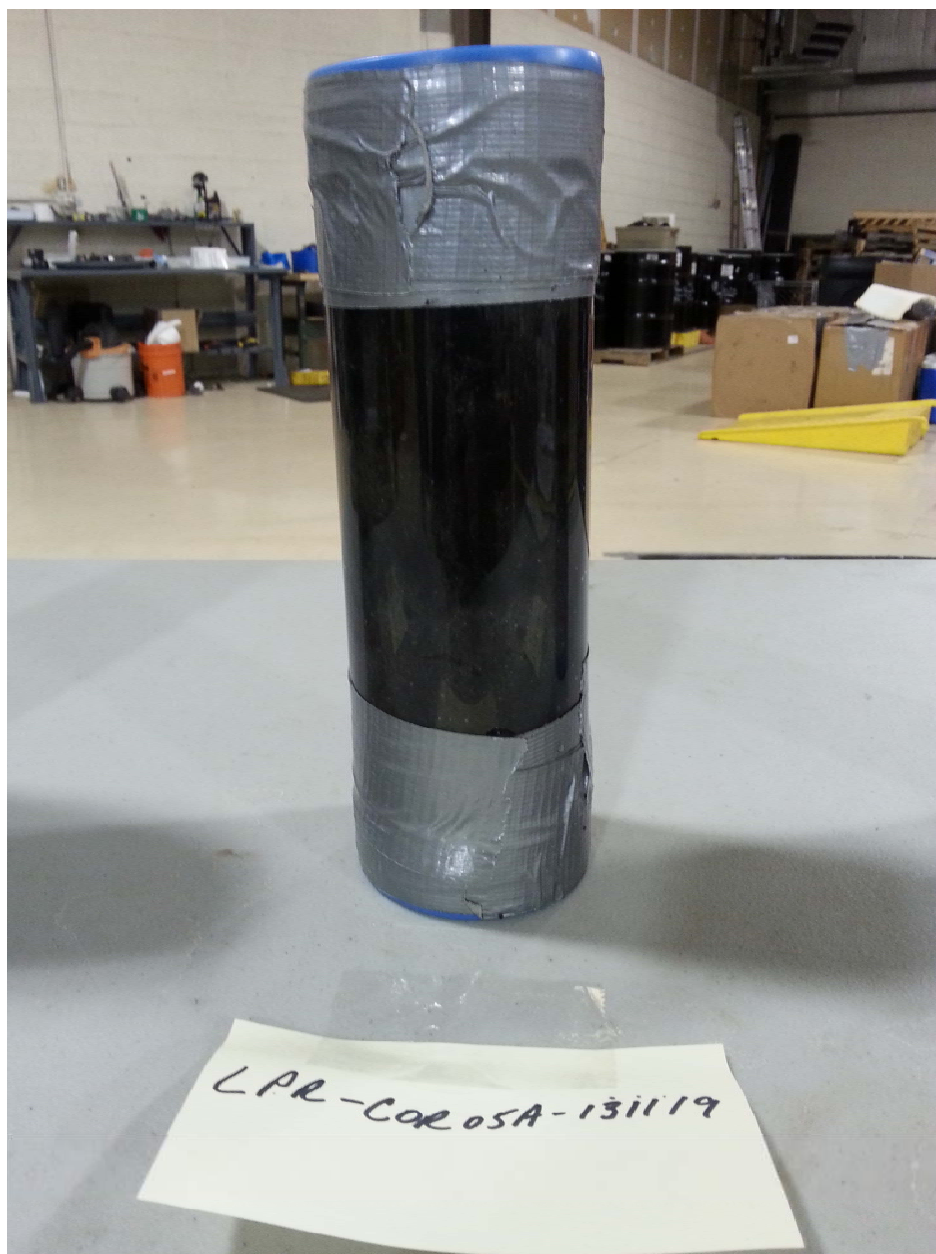
November 21, 2013 1430: Sediment core collected by CH2M Hill on November 19, 2013. The core was collected to determine the makeup of the cap, by visual analysis and TOC analysis. This is the 10-inch sample of cap, to be sent to lab for analysis. It is difficult to differentiate between the sand and AquaGate because the core is now frozen.

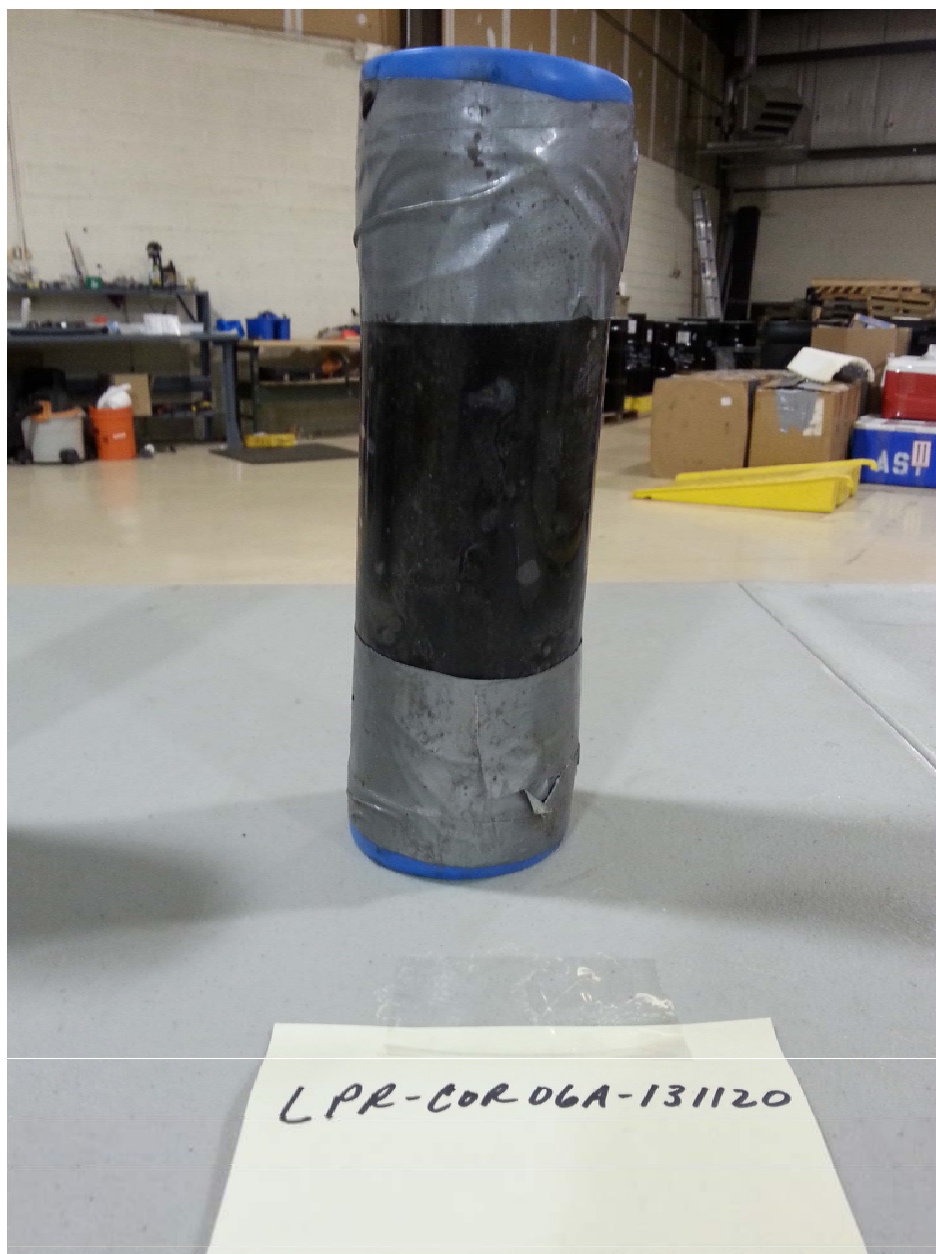
November 21, 2013 1430: Sediment core collected by CH2M Hill on November 20, 2013. The core was collected to determine the makeup of the cap, by visual analysis and TOC analysis. This is the 10-inch sample of cap, to be sent to lab for analysis. It is difficult to differentiate between the sand and AquaGate because the core is now frozen.

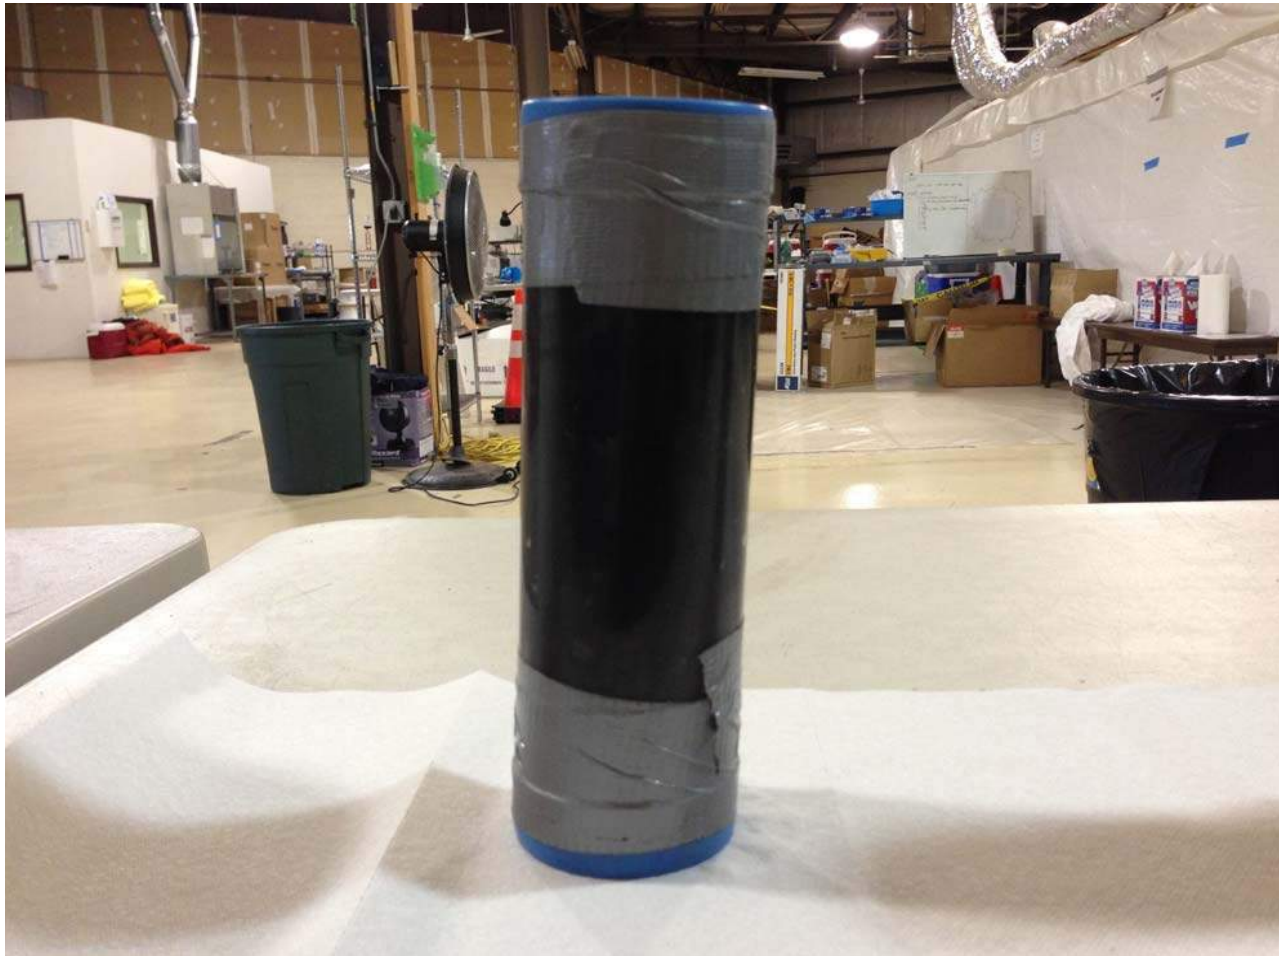
Core Sample

CH2M Hill shipped out for TOC analysis the core samples collected last week. The samples contain only the sand/AquaGate layer (approximately 10 inches) and none of the underlying material. The samples were uniformly colored (nearly black) and free of observable heterogeneities.

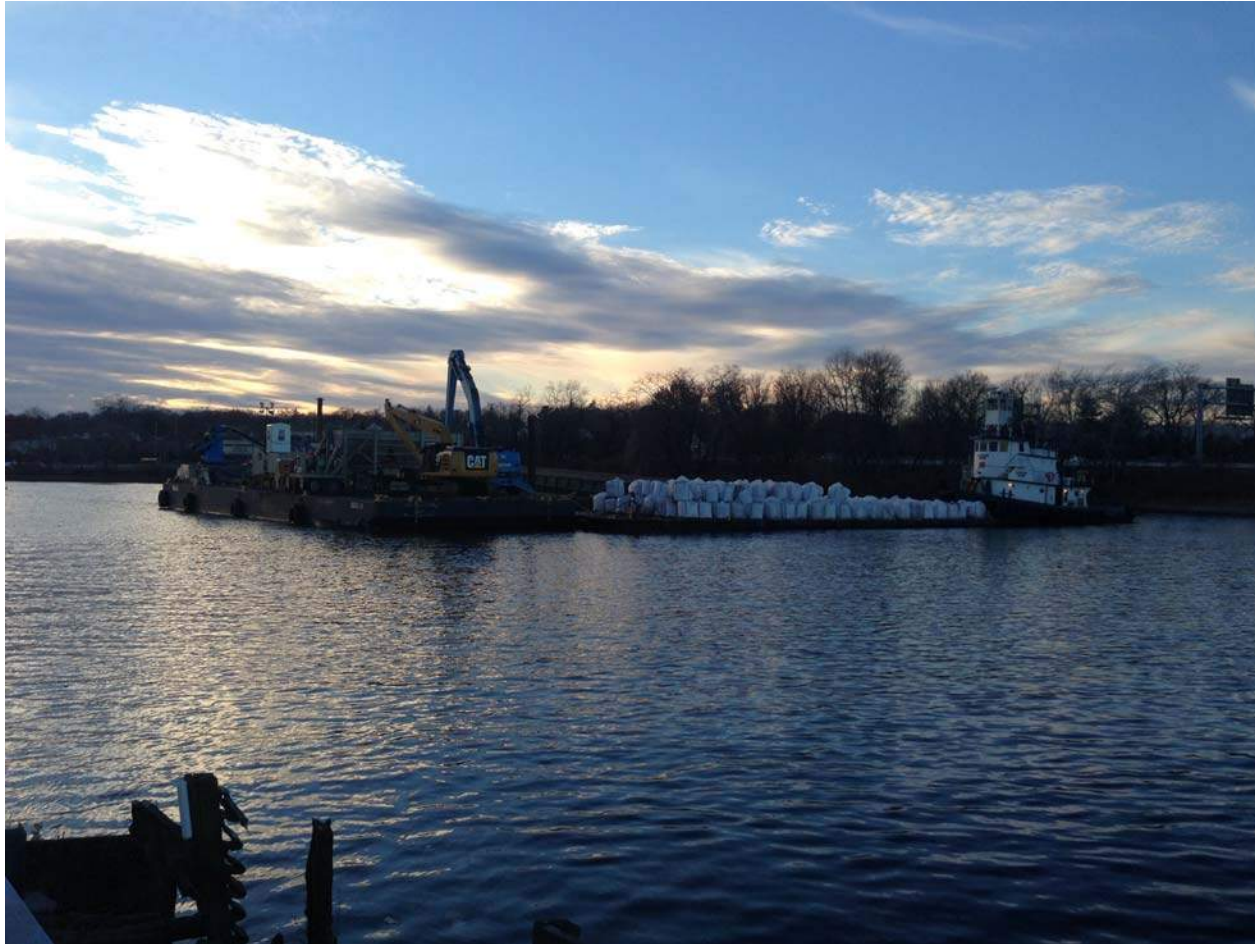
AquaGate shipment

GLDD were only able to place capping material for approximately 40 minutes this morning due to a shortage of AquaGate. The above-pictured barge arrived at RM 10.9 at 1600 and was followed by a second barge filled with sand.

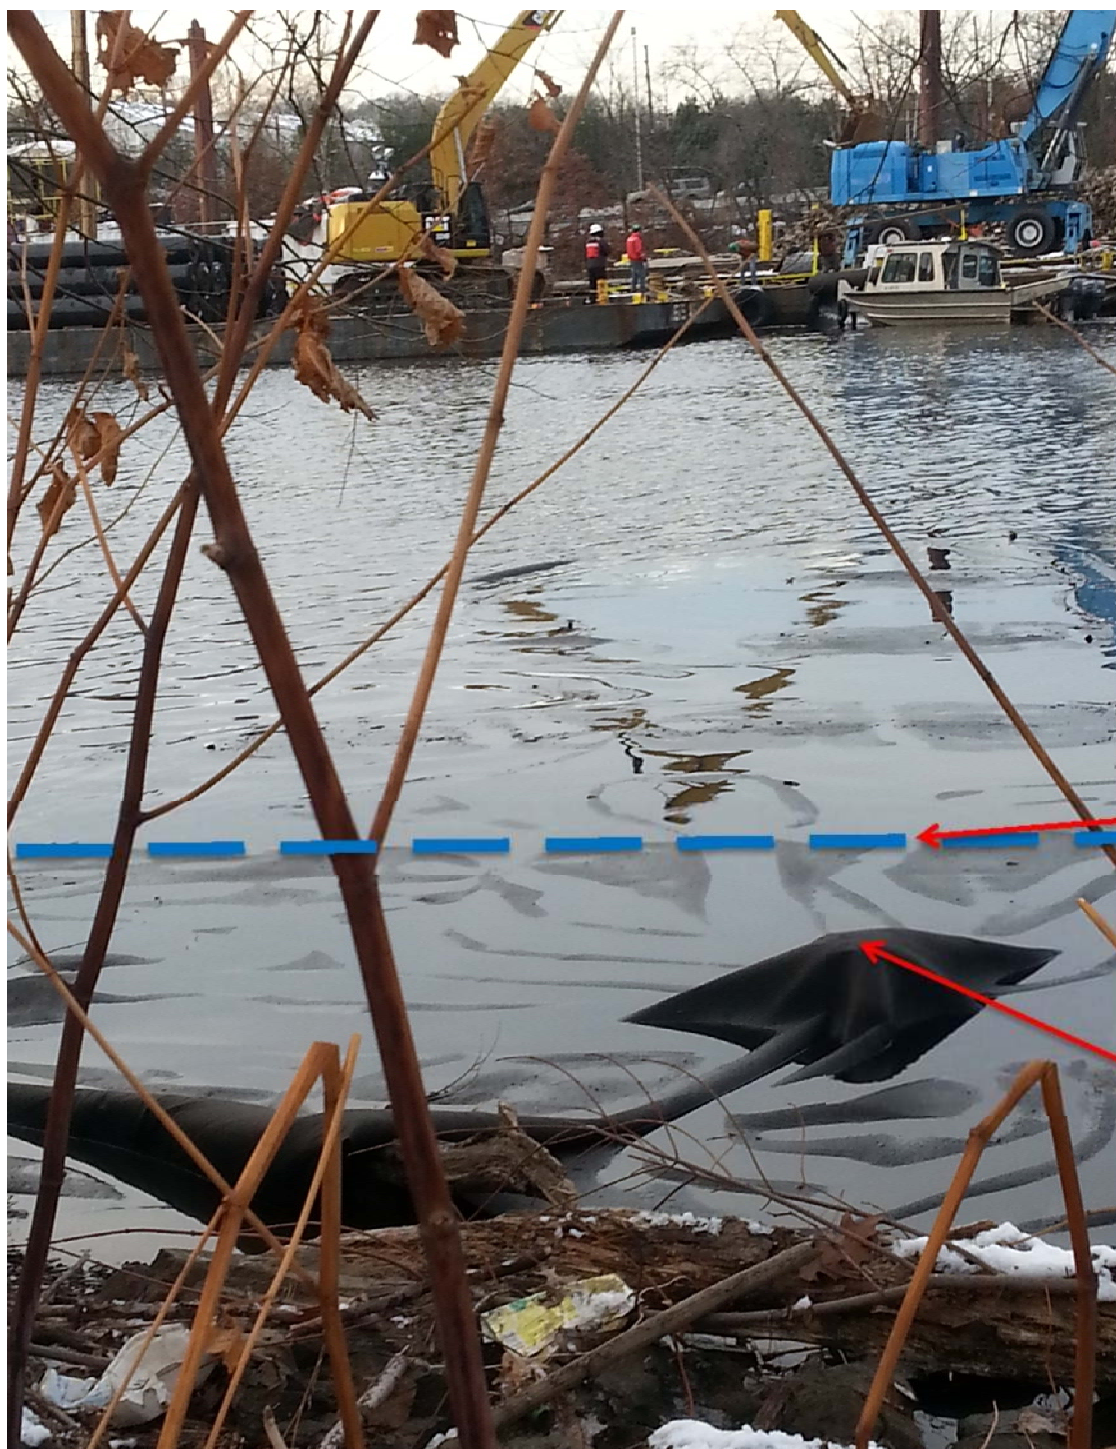
December 11, 2013 1600: First attempt at installing geotextile fabric. The fabric was installed in an "S" shape and not fully anchored. GLDD purposely installed the fabric higher on the shoreline than specified in the design. During low tide tomorrow, GLDD will trim back the fabric to the design elevation, and anchor it with the Type A armor stone.

Approximate edge of elevation design. GLDD will cut the fabric down to this line during low tide tomorrow

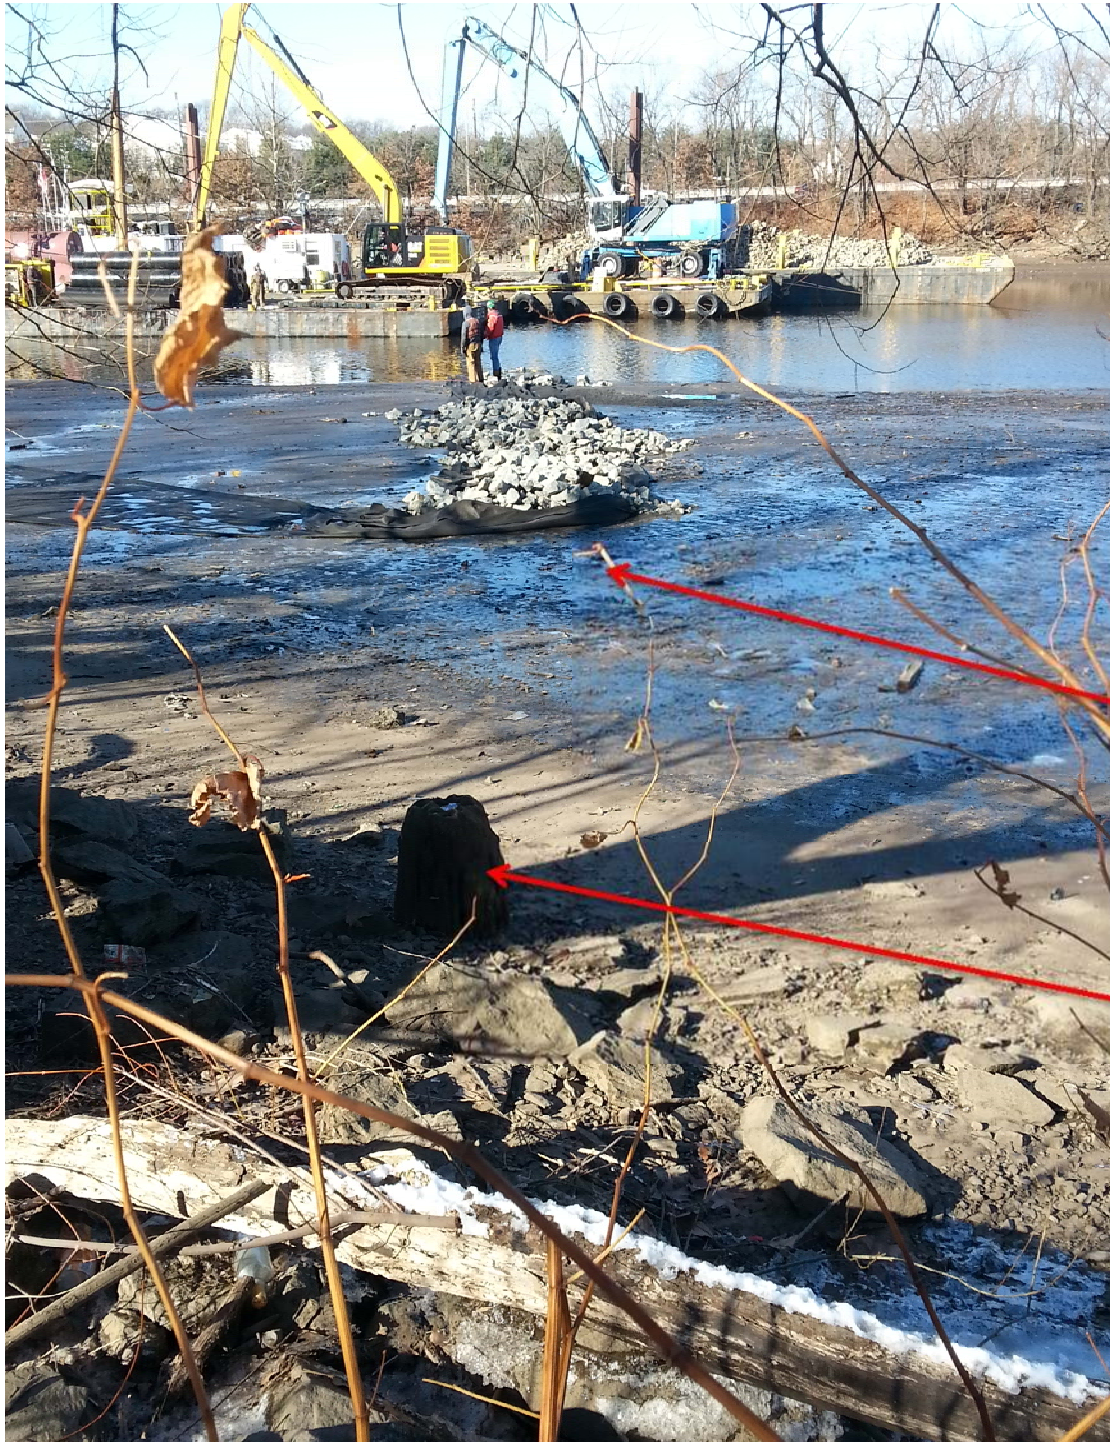
December 12, 2013 1130: First panel of geotextile fabric installed yesterday. The fabric was installed in an "S" shape and not fully anchored. GLDD pulled the fabric down a little past design elevation (survey stake denotes edge of design elevation).

Survey stake denoting edge of design elevation.

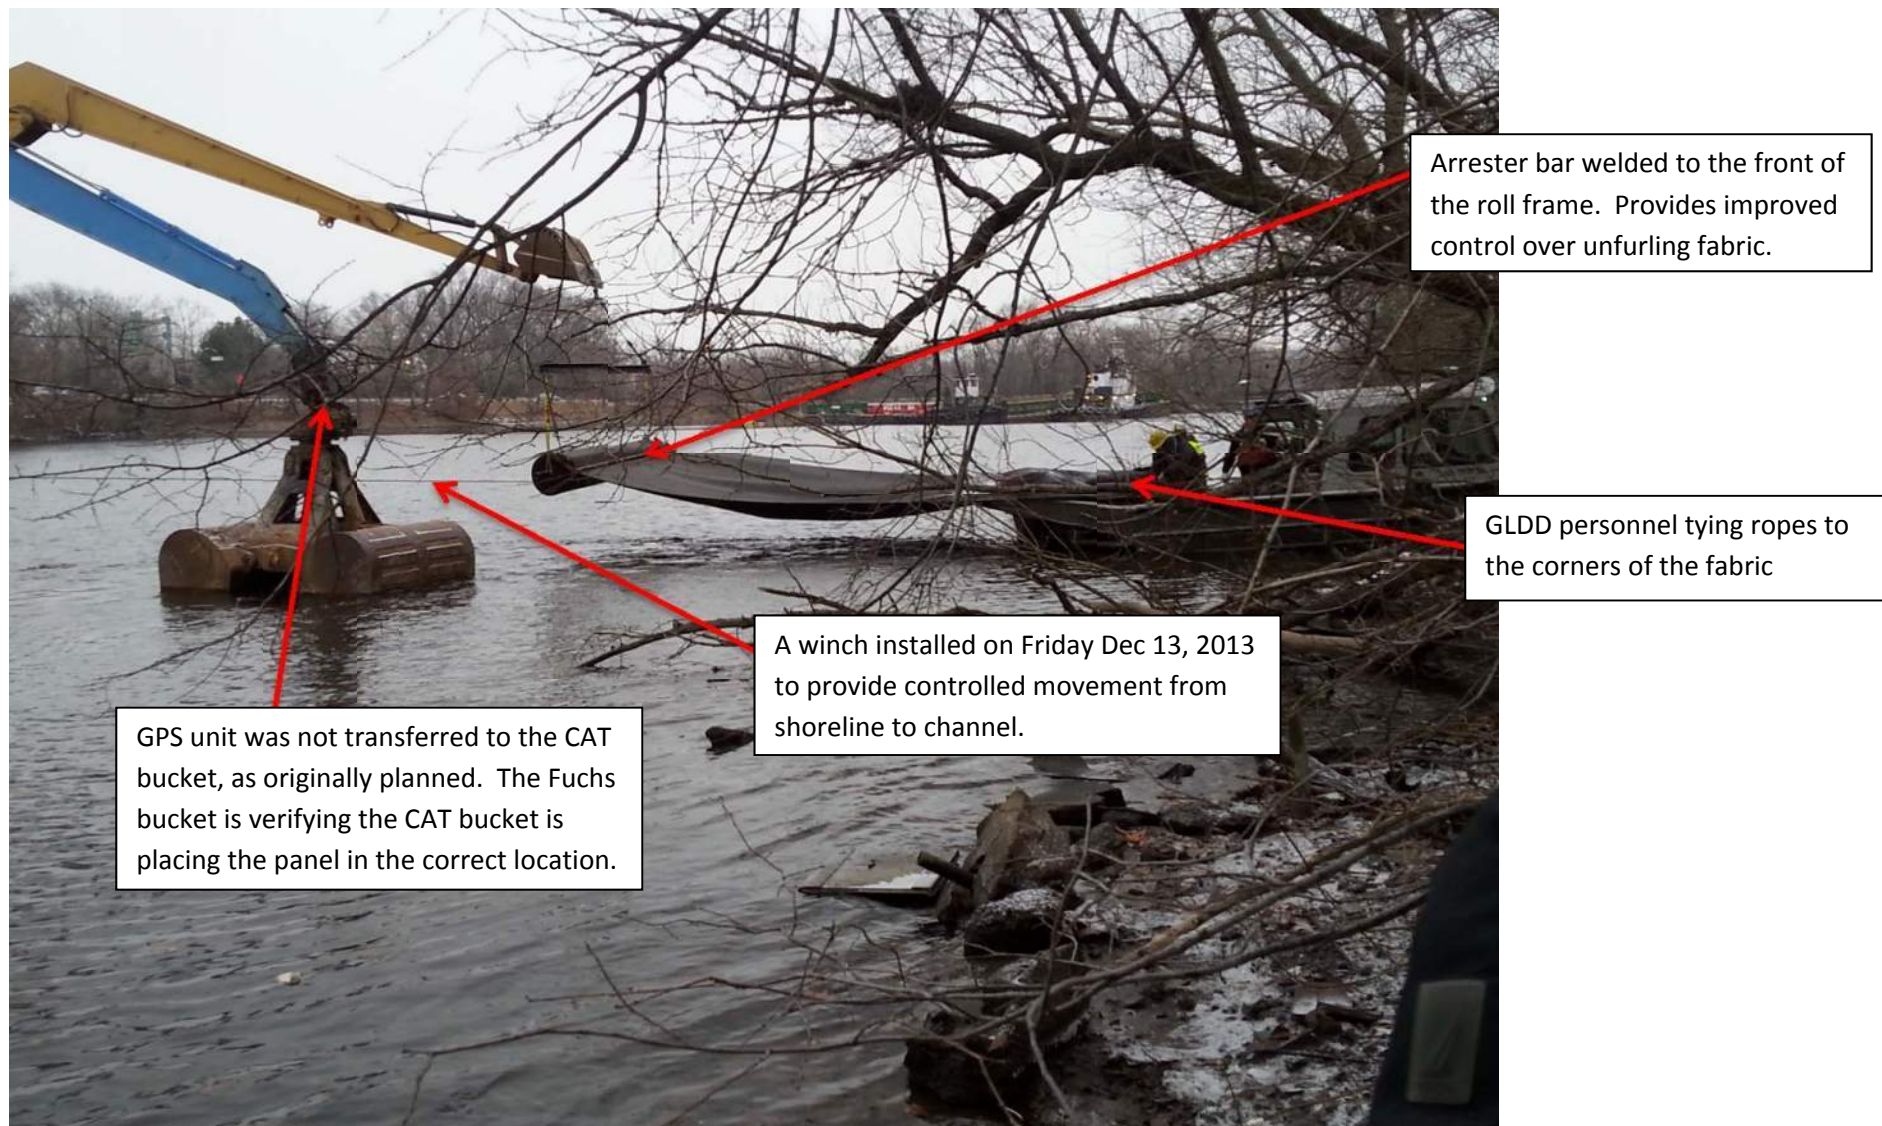
December 14, 2013 0745: Second panel of geotextile fabric installation started.
